# WMATA Viaduct Crack Mapping

In 2015, NEXCO performed a bridge inspection using their surface imaging system at the Bush Hill Viaduct owned by the Washington Metropolitan Area Transit Authority (WMATA). The objective was to deliver a deficiency map for both girders and piers, as well as a cracks and deficiency summary for each pier.

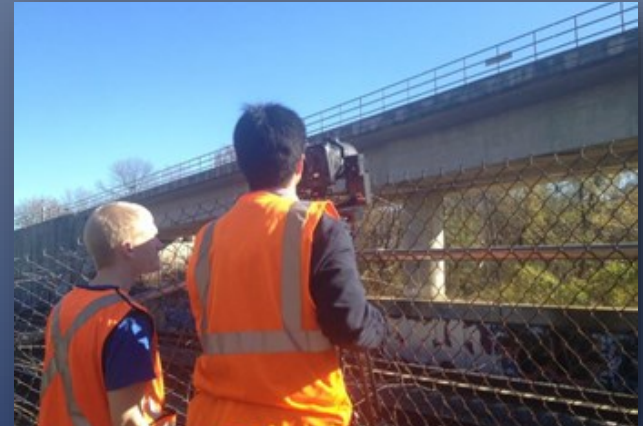
FACE	(North Girder) Crack summary			Total Crack Length
	Narrow (-1/16")	Medium (1/16"-1/8")	Wide (1/8")	
NORTH OVERHANG	63	0	0	63
NORTH WEB	53	0	0	53
BOTTOM	125	0	0	125
SOUTH WEB	13	0	0	13
SOUTH OVERHANG	63	0	0	63
Total	317	0	0	317
