VDOT

Infrared Bridge Deck Scanning

SUMMARY

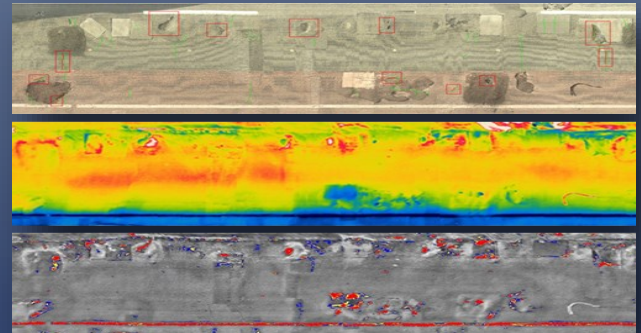
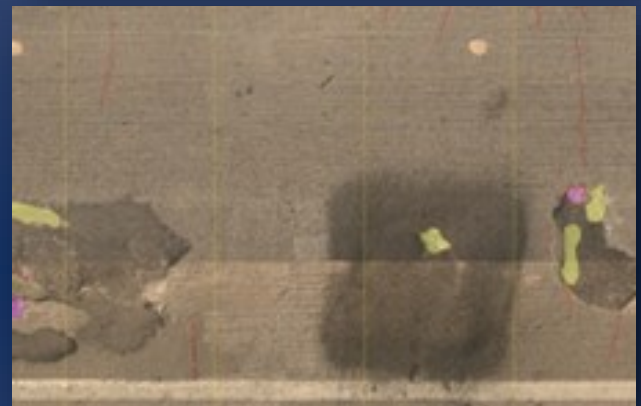
Insignificant	Moderate	Severe
Crack Size	< 1/16"	1/16" to 1/4"	>1/4"

The technology proved effective in the identification and quantification of both cracks visual on the deck's surface, and sub-surface delamination detectable only by infrared.

Bridge owners can use this information to prioritize the bridge deck repair and/or adjust rehabilitation schedules to allocate limited budgets and obtain the maximum return on investment for network level bridge management.
