# Ohio DOT Infrared Bridge Deck Scanning

In 2014, NEXCO-West USA worked with the Ohio Department of Transportation (ODOT) to evaluate numerous bridges using infrared and high-resolution cameras. The purpose of this project was to provide infrared thermography scanning in a corridor including six bridge decks on IR-75 in Hamilton County, Ohio (between Brent Spence Bridge and the Western Hills Viaduct Interchange). In addition, this project demonstrated NEXCO's ability to scan in highly trafficked areas without the use of a lane closure.

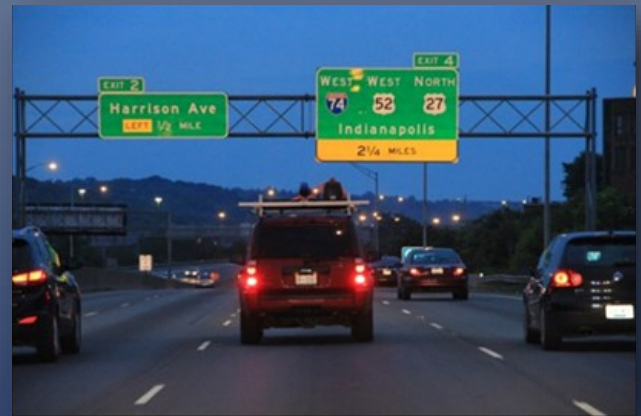
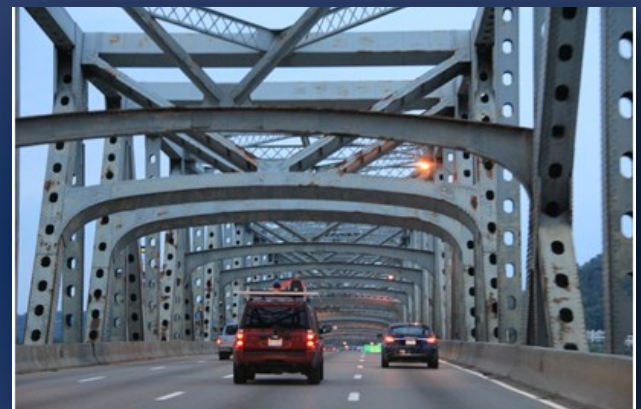
The data gathered was processed and interpreted by experienced engineers to identify unsound concrete that would require repairs to extend the life of the structures for an additional ten years. A summary table of delaminated area and AASHTO element level condition states for each span/line of the bridges, as well as geolocated images describing the location of delaminated areas was delivered.
