Project Details

Client	[Engineering Firm in Virginia]
Surface Area	1 Bridge, 130,000ft ²
Project Period	12/2021

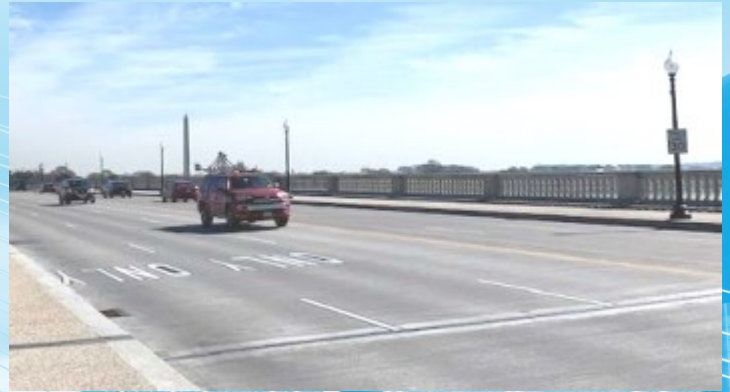
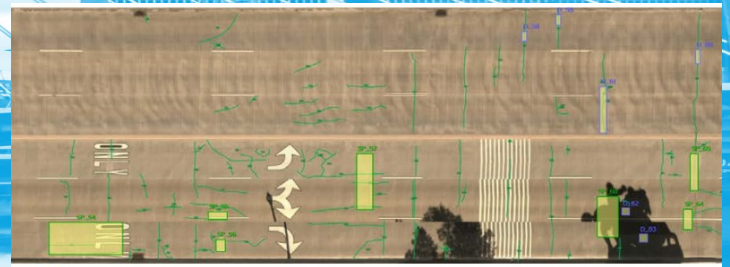
Using our Deck Top Scanning System (DTSS), NEXCO captured infrared and HD visual data to detect any potential deficiencies present in the newly-built deck cover. The HD visual imagery was used to perform detailed individual crack width detection. The shape, width, and length of the cracks were recorded in the scaled imagery and reported in table form for the prime contractor's review.
