Project Details

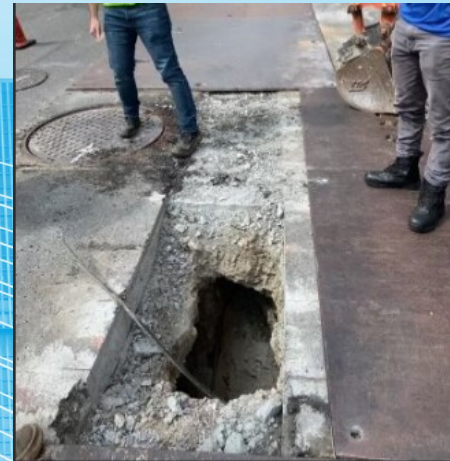
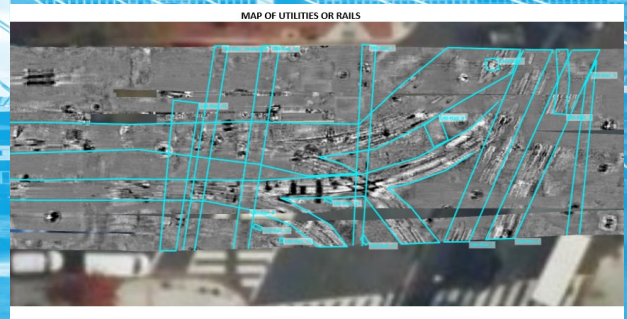
The scan revealed the location of various utility lines, as well as old trolley lines to avoid during milling/sawing of the road surface.
