Entire Box Girder Bridge Scanning

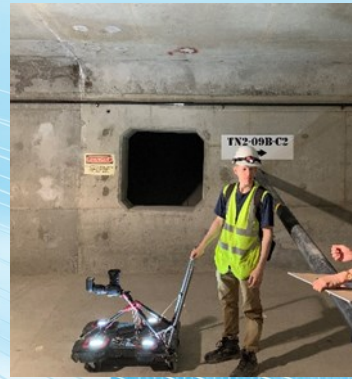
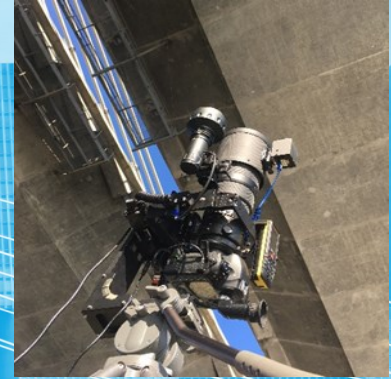
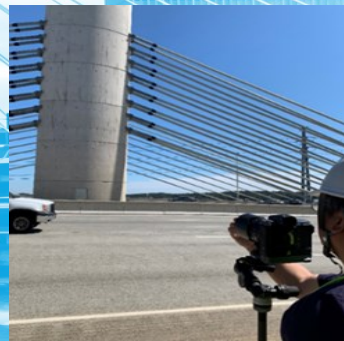
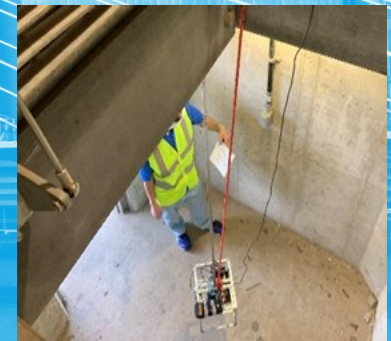
Five distinct methods of visual and infrared imaging were utilized capture all structural surface types. To capture the deck top, our vehicle-mounted DTSS system was used. To capture box girder and pier tower exteriors, hand-held, and tripod mounted sensors were used. To capture box girder and pier tower interiors, cart-mounted and cable-suspended sensors were used.

The resulting data allowed imagery to be built into scaled plans of each bridge segment. Analysts reviewed the plans sheets and notated cracks, delamination, efflorescence, and spalls.
