Application Note

Mobile Infrared Scanning – A High-Tech, Accurate Alternative To Traditional Bridge Inspection Methods

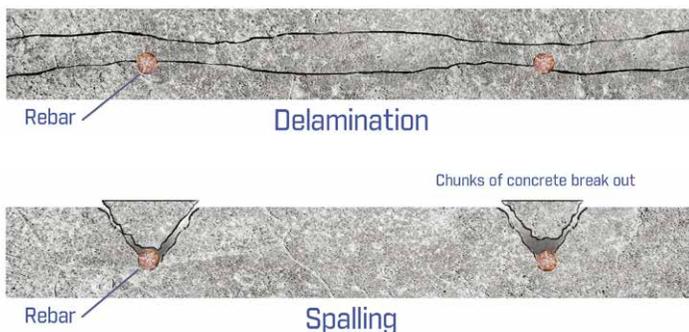
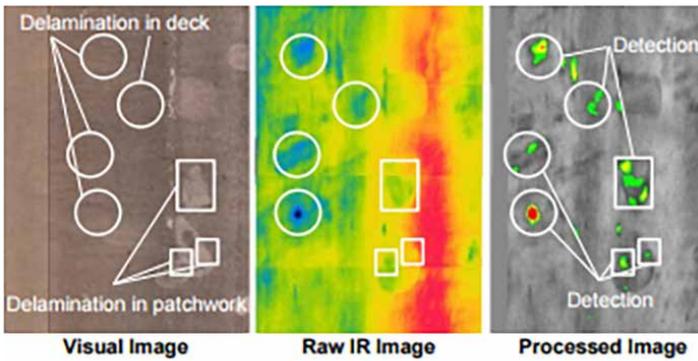
Visual, raw, and processed delamination images from IR survey of bridge deck

Source: "Comparison of Infrared Cameras for Concrete Bridge Deck Scanning: - Vol.2 Field Test at Haymarket Bridge", December 2014, NEXCO-West USA, Inc

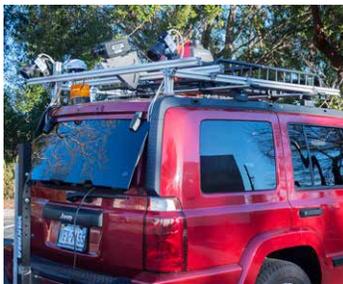
NEXCO-West's mobile survey setup

"NEXCO-West's approach to testing for bridge delamination is a mobile method, using an infrared camera installed on top of the vehicle," says company President and CEO, Masato Matsumoto. "Our approach does not require lane closures or speed limit reductions, so it keeps traffic flowing while simultaneously keeping inspectors safe."

Inspections are performed with a truck-mounted infrared camera while driving across the bridge at 50 miles per hour with traffic. Matsumoto says it only takes a few minutes for the infrared camera to record an entire scan of one lane of a one-mile long bridge.

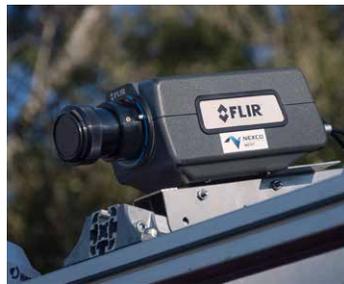
FLIR A6701sc camera used to create infrared delamination maps

The camera employed in NEXCO-West's scanning system is a FLIR A6701sc MWIR science camera. "We use the A6700 series camera because it can photograph high resolution thermal images while driving at high speed," explains Matsumoto. This camera's cooled Indium Antimonide detector offers integration times as fast as 0.48 μs, allowing the team to record 640 x 512 pixel thermal images without any motion blur. Matsumoto says they typically set the camera for a 10 Hz frame rate, which allows it to record a crisp thermal image every two meters at highway speed. The camera is connected to a laptop inside the vehicle that is running NEXCO-West's Infrared Bridge Assessment System (IrBAS) software, so the team can see real-time analysis and recognize potentially delaminated areas.

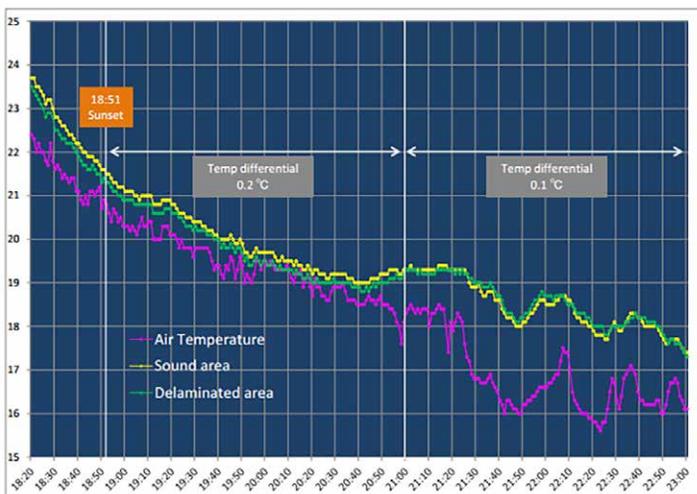
Example of temperature differential for sound and damaged concrete

Source: "Comparison of Infrared Cameras for Concrete Bridge Deck Scanning: - Vol.2 Field Test at Haymarket Bridge", December 2014, NEXCO-West USA, Inc

Scans are usually performed during the day or within a few hours after sunset, when large temperature shifts can be observed. For example, concrete that heated up during the afternoon will begin to cool down after sunset, creating a measurable change in temperature. Most of the deck will heat or cool evenly, but delamination interrupts the conduction path. The temperature of the damaged concrete will rise more rapidly during the day and fall faster at night, which is easily detected by the IR camera.

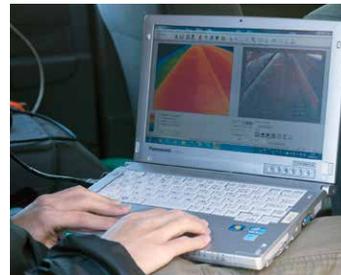
Laptop shows live-streaming infrared through NEXCO-West's IrBAS software

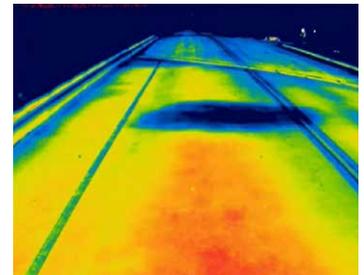
Thermal image used to create bridge deck deficiency map

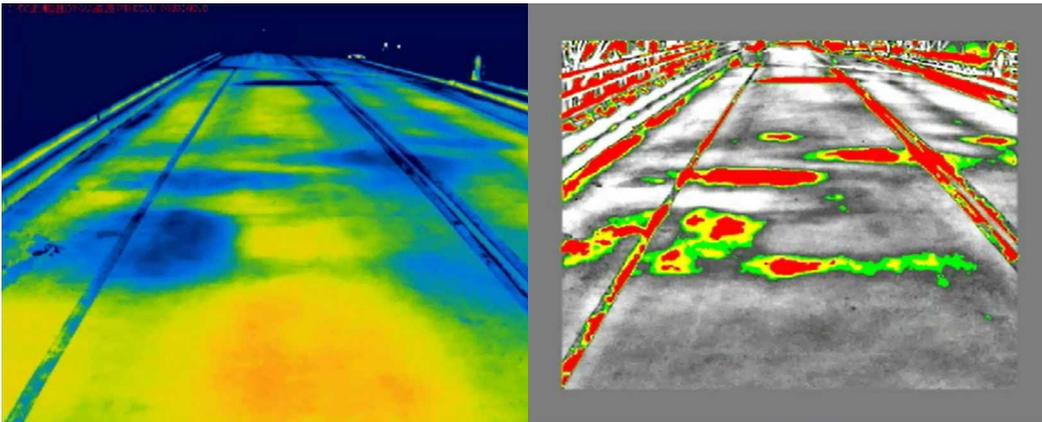
Thermal bridge scan (left) and IrBAS processed image used to create deck deficiency map (right)

After the team has collected data on each lane of the bridge, they can begin processing it. "Most of the data analysis and reporting processes are automated by the IrBAS software, which saves significant time and cost preparing deficiency maps," says Matsumoto. The software uses the deficiency map to calculate the percentage of delaminated deck area and then classify the condition states based on American Association of State Highway and Transportation Officials (AASHTO) criteria.

There are three damage categories:

1. Indication: Delamination is present within 4 cm of the concrete surface
2. Caution: Delamination is present within 2 cm of the concrete surface

3. Critical: Delamination is reaching the concrete surface

Deck areas that rate Indication are considered satisfactory, while Caution areas require close monitoring. Any area rated as Critical requires immediate action.
